A350 In-Service Summary

Sichuan
Airlines

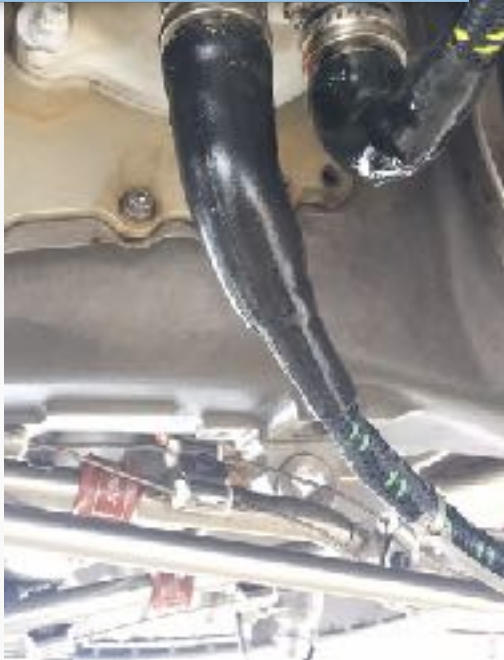
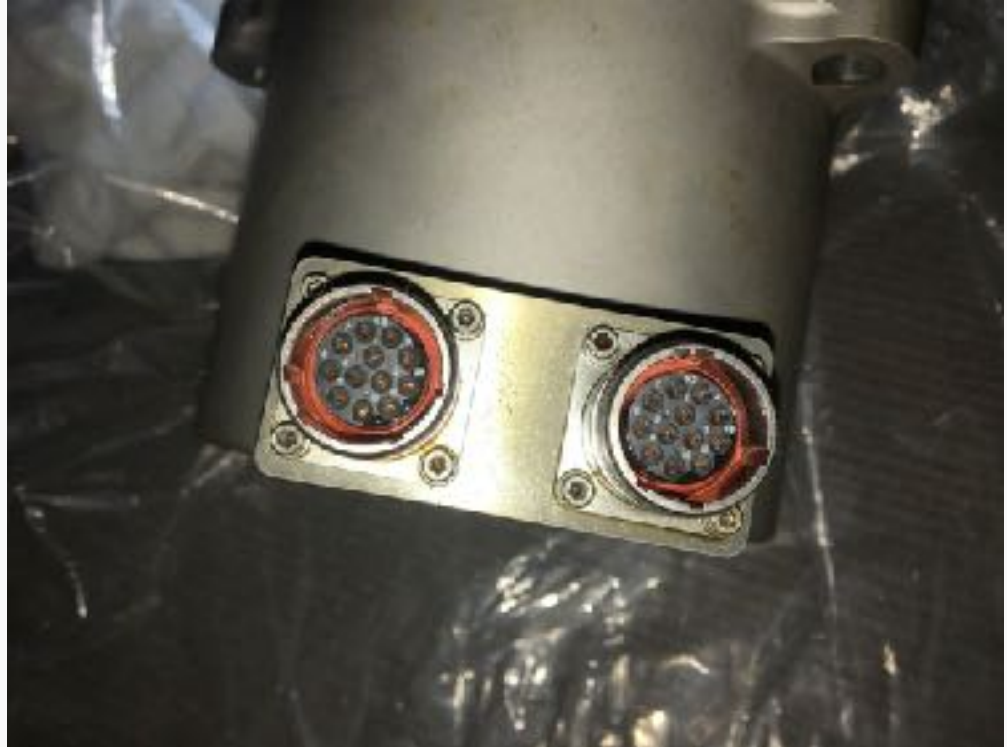
Failure Description	Solutions
Right wing tank's fuel goes into center tank	5604QA2、5605QA2(VALVE-CENTRE TANK, NON RETURN)、5601QA2、5602QA2(PUMP-JET, FUEL SCAVENGE)、5302QA2、5302QA1(VALVE-AIR RELEASE)、5600QA2(VALVE-SCAVENGE, FUEL), were replaced and sent for repair.
PMA electrical plug Leaks	Replaced PMA stator.
F/CTL FLAP PCU 2	PCU was replaced.
TRAS Gimbal pin retainer clip slide out of position	Replace the clip by new PN: 351-3021-1.

oil leakage has been observed from the PMA electrical connectors on other Trent series engines utilising the same design, therefore a similar potential for oil
